LAWRENCE
LIVERMORE
NATIONAL
LABORATORY

Instron Investigation Testing Report

S. Franco

February 17, 2015

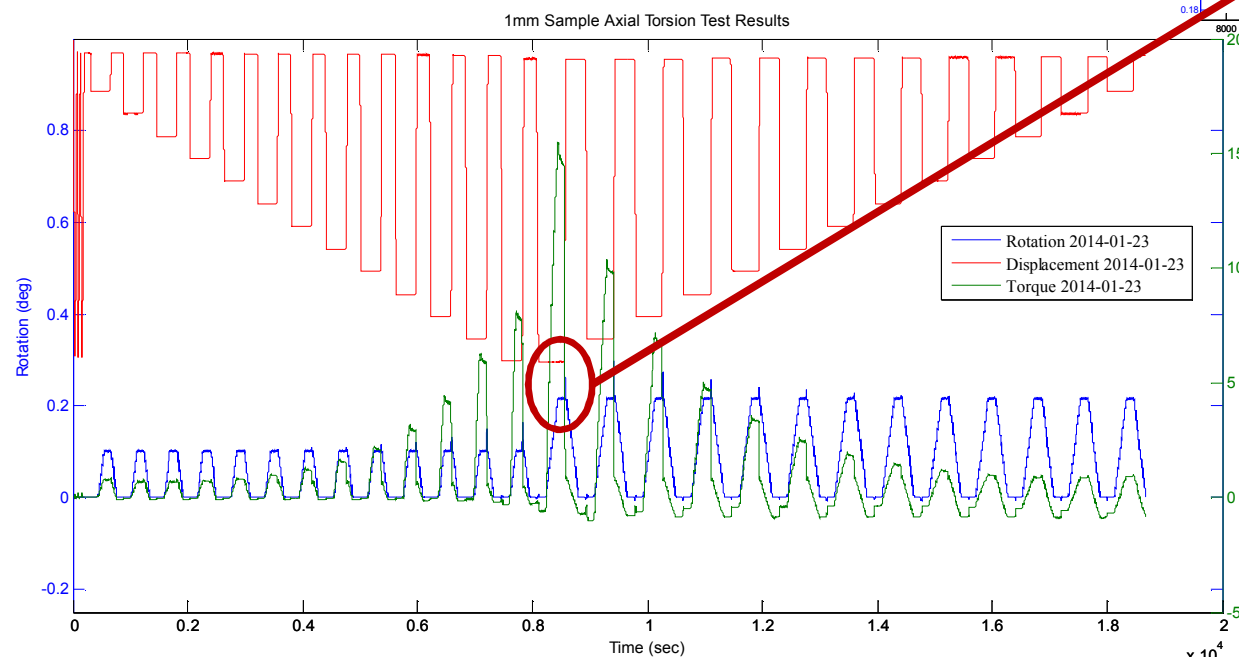
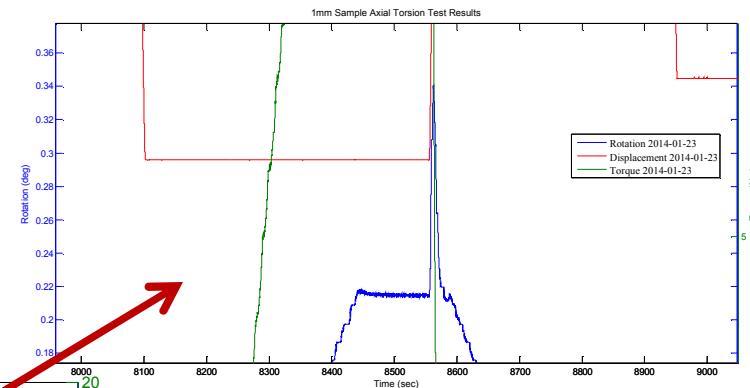
Rotation Spike Investigation

- Rotation spikes are observed when the sample is under both axial and torsion loads and then the axial load is removed.
- The spikes increase in amplitude as the axial loading increases.

- Rotation spikes may be due to the control system of the Instron.
- There is a force output from the rotational actuator and the sudden drop off in axial load causes the actuator load output to be higher than that required to maintain the set rotational angle. There is then a lag time until this is corrected.

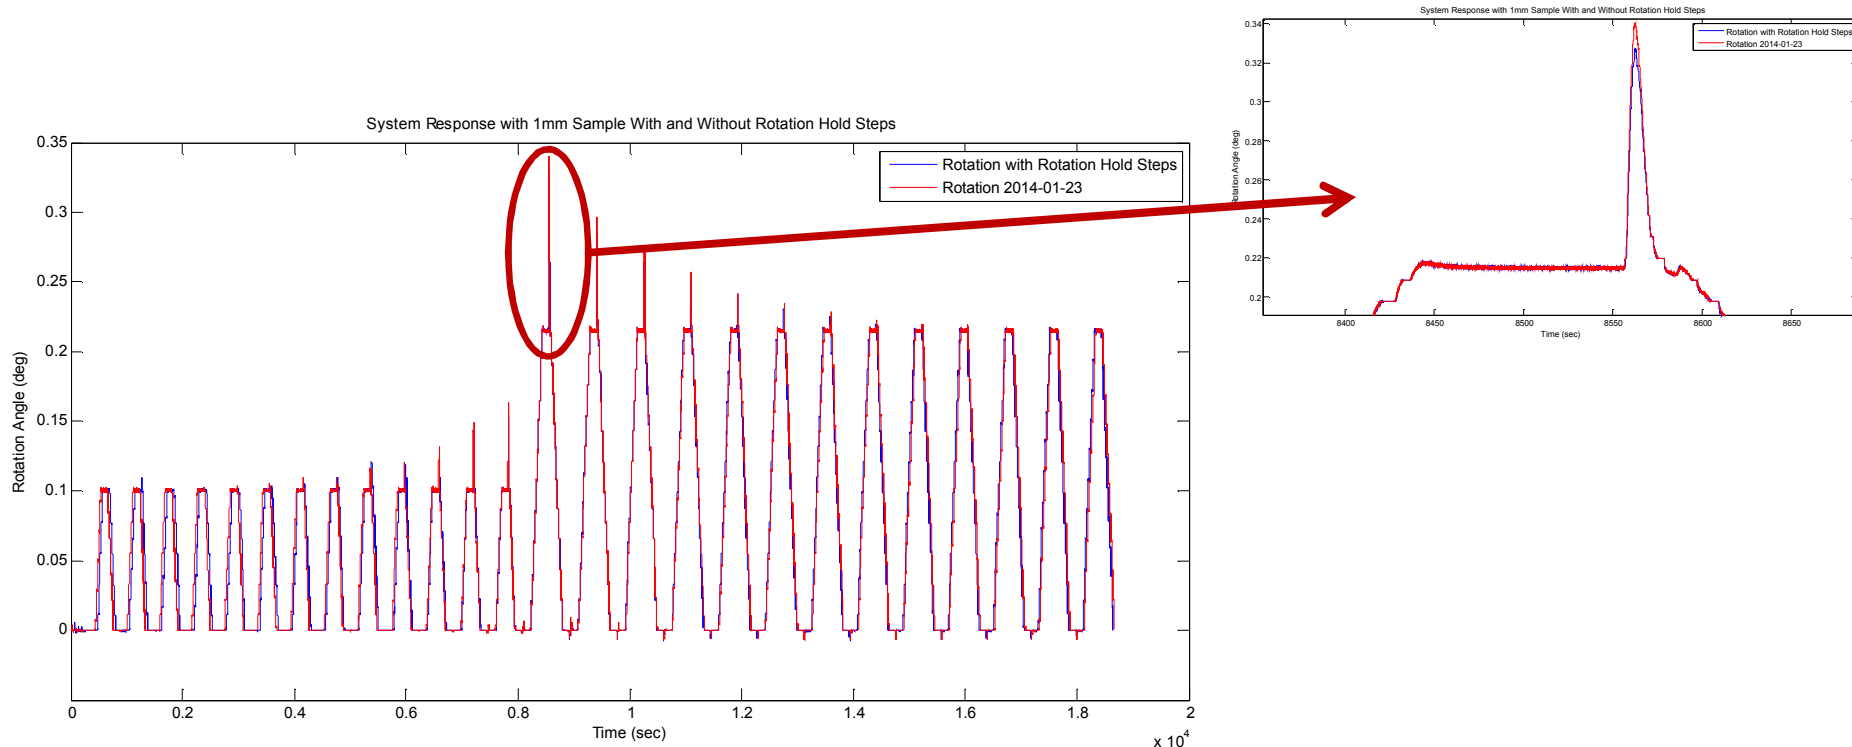
Rotation Spike Investigation – Add Rotation Hold

- The Instron Test Method (control steps) was modified to add Rotational Hold steps while unloading the sample axially. Previously no rotation step was defined during the axial unloading steps.
- The results showed no change in the rotational angle spikes.

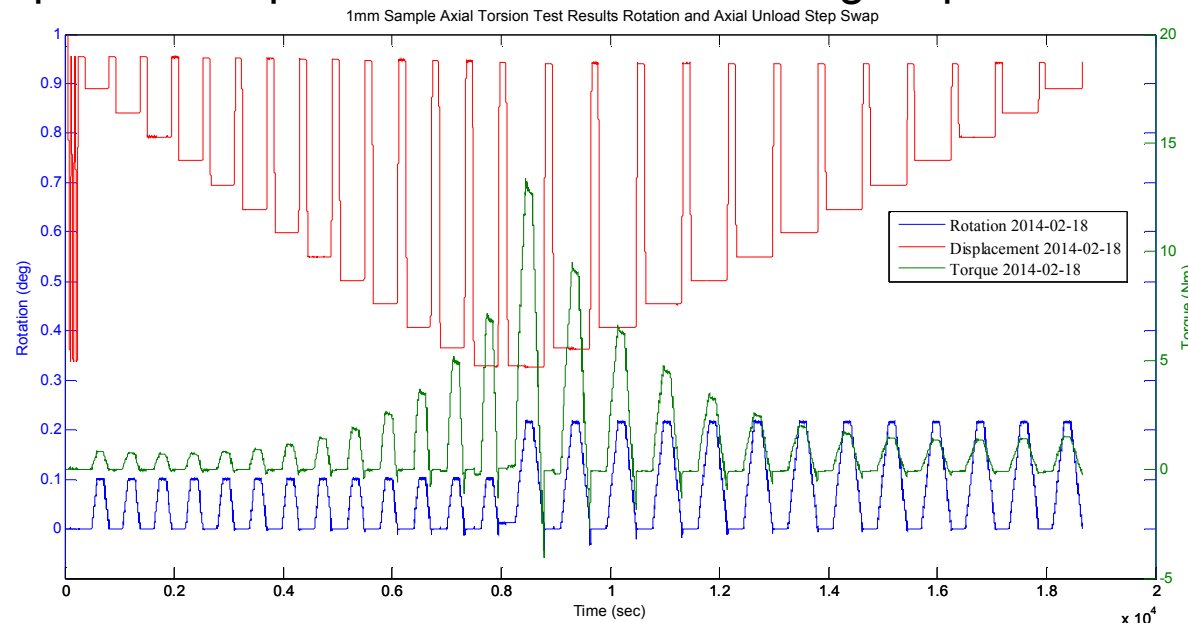
Rotation Spike Investigation – Swap Steps

- The Instron Test Method (control steps) was modified to swap the order of the axial displacement unloading and rotational unloading steps.
- The results show that the rotation spike is still present, but now a lower amplitude and opposite direction. The spike still corresponds in time to when the axial load is removed
- There is now a more apparent spike in the torque. It is also negative and the peak of the spike corresponds to the axial unloading step.

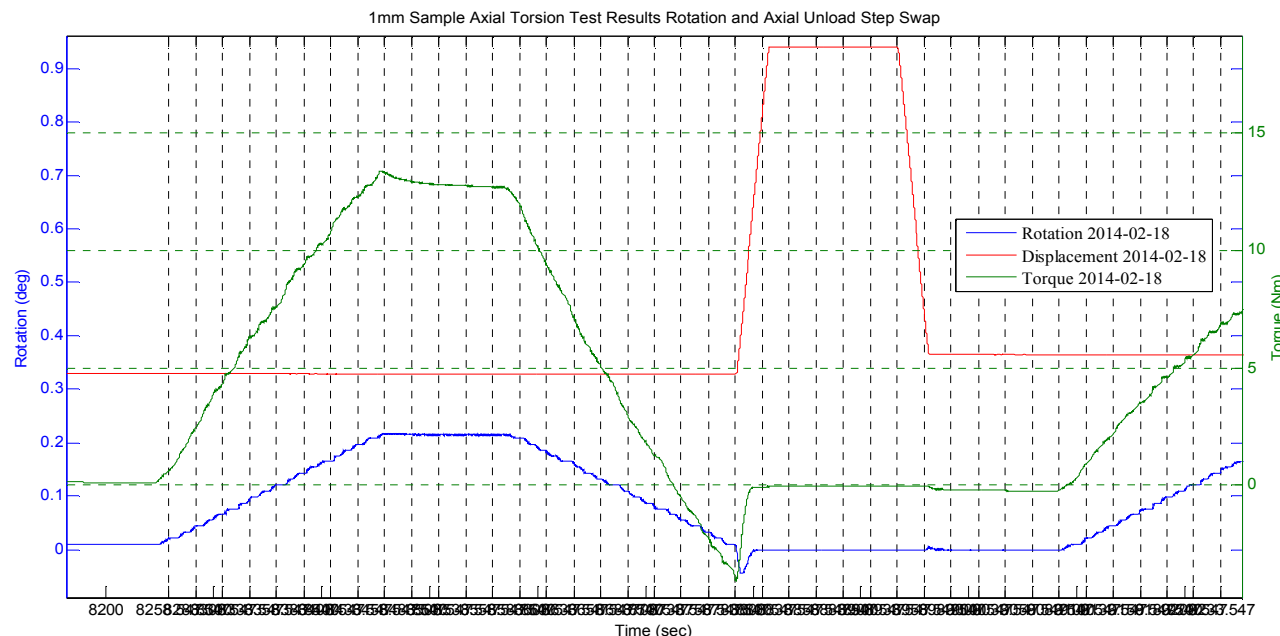
Rotation Spike Investigation – Swap Steps

- The torque goes negative before the rotation returns to zero position. This is either an indication of the non-linear properties of the material or that slipping between the platens and the sample is occurring.
- The torque does return to zero after the axial unloading step. This could be due to the material compliance increasing while not loading.
- The spike in the rotation curve could still be due to the response time of the rotation actuator.

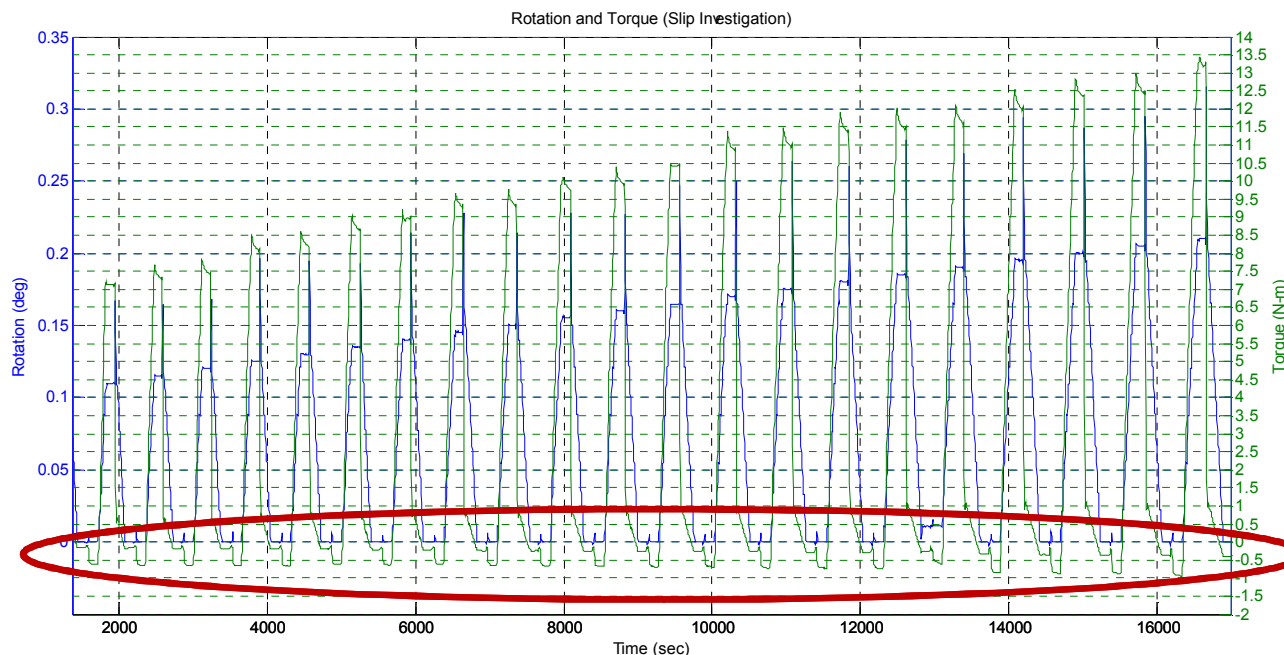
Slipping Investigation

- Through the testing, it was noted that the torque value would not return to zero, but go instead through zero into the negative.
- This also appeared to get worse as the number of cycles increased.
- In order to explain this, we attempted to determine if slipping was occurring between the platens and the material sample. Slipping would explain why the torque value would get more negative as the number of cycles increased even though the rotation was returning to zero every time.

Torque becomes more negative as the number of cycles increases

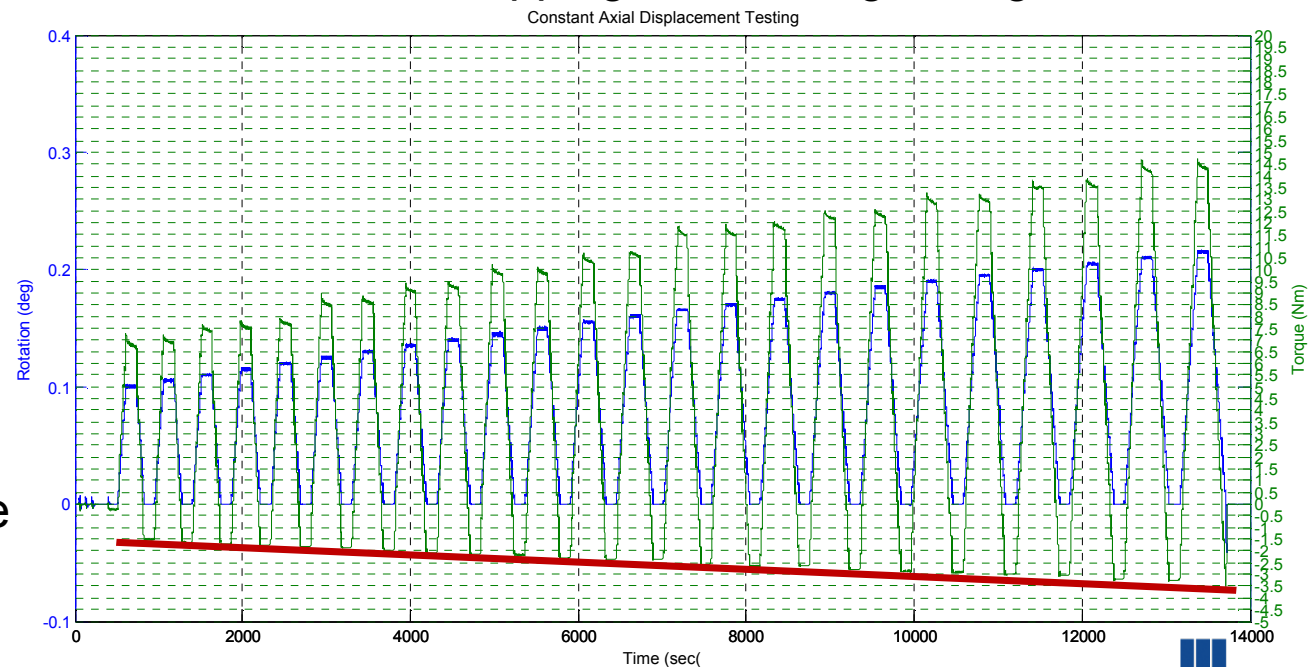
Slipping Investigation – Constant Axial Displacement, Varying Rotation

- Besides the number of cycles increasing, the previous tests also had an increasing axial displacement and therefore load with each cycle.
- In order to determine if the axial load had an effect on the torque, constant axial displacement tests were conducted. The axial displacement was applied and then held for the duration of the rotation cycles.
- The test still showed increasing negative torque values as the rotation angle increased. This result is an indicator that slipping is occurring during the tests.
- If slipping is occurring, it is happening through all tested rotation angles.
- It should be noted that the spikes in the displacement are not present due to the axial loading and unloading.

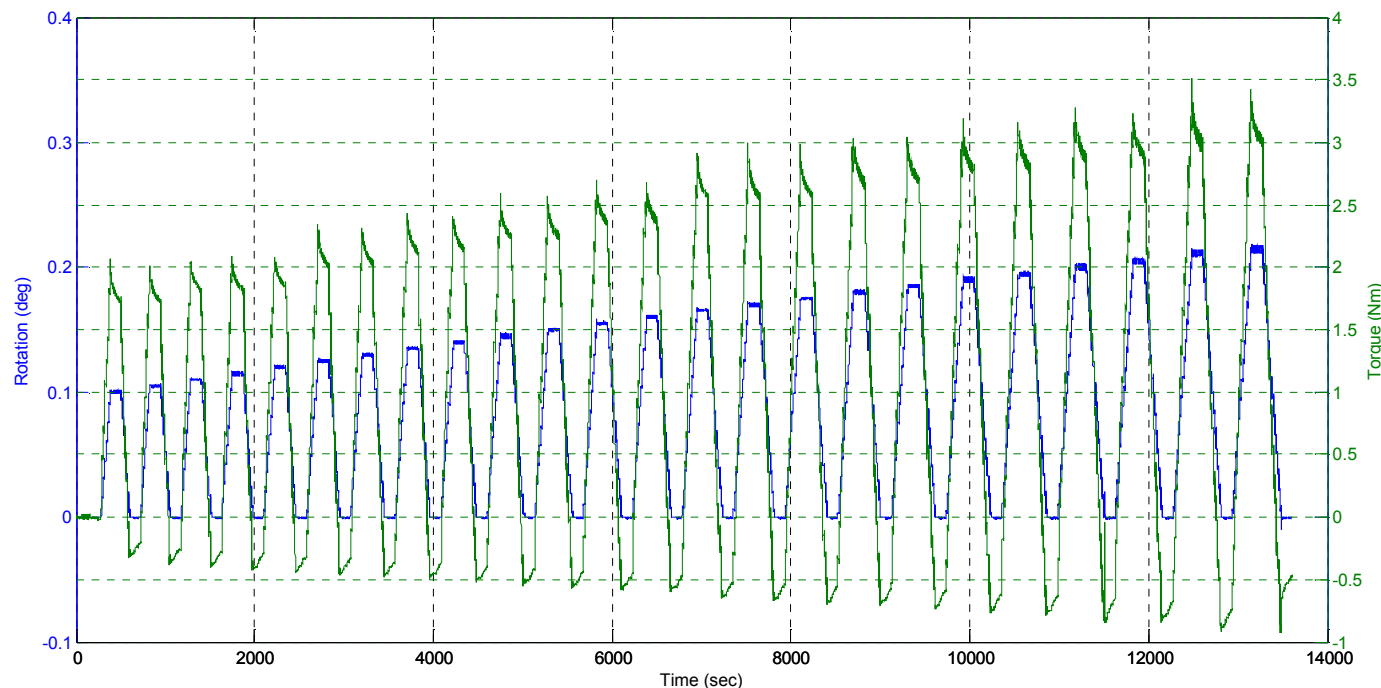
Slipping Investigation – Constant Axial Displacement, New Material 1 (Black Rubber)

- In order to see if the material under test was affecting the torque data, another material was tested in its place.
- This material was a 1.63mm thick black rubber.
- The results show that the torque still goes negative and increases with rotation angle.
- This would indicated that slipping is also occurring with this material.

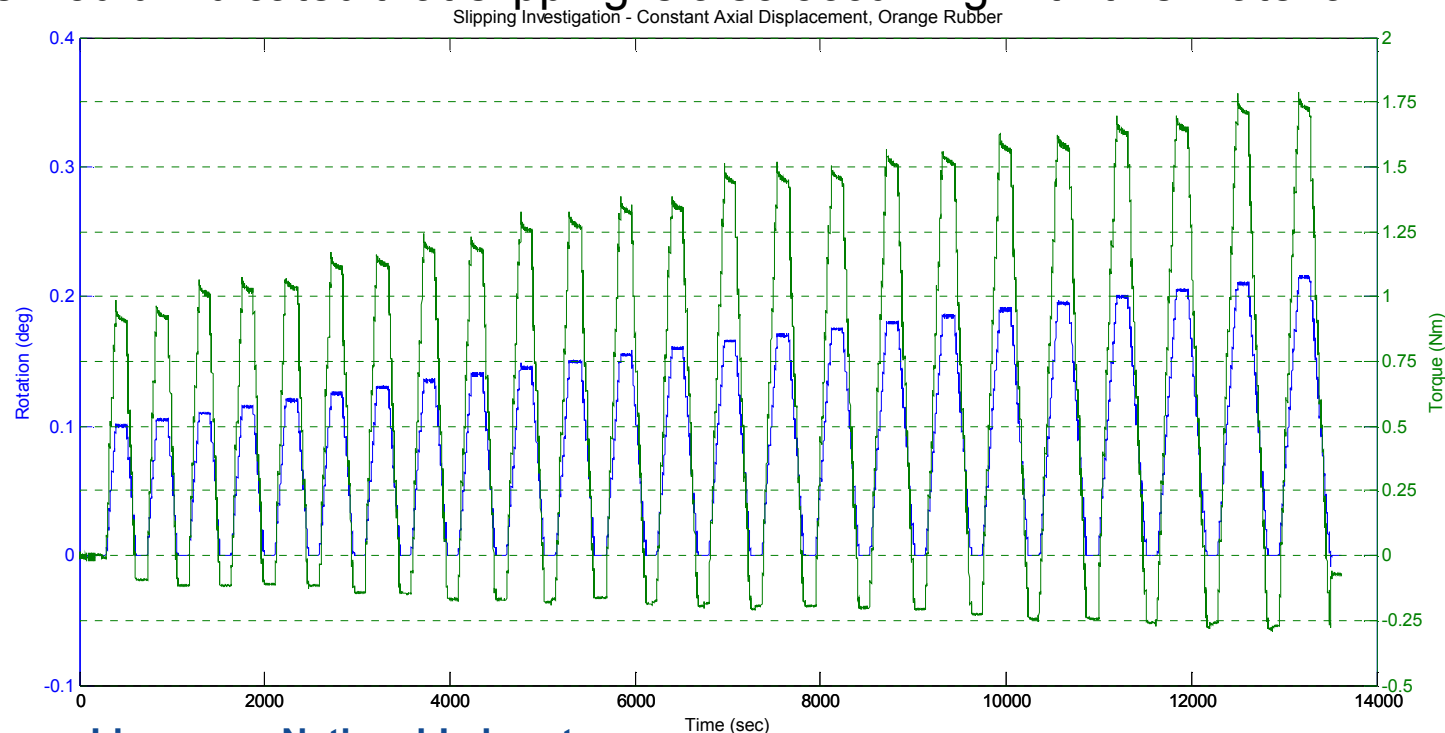
Slipping Investigation – Constant Axial Displacement, New Material 2 (Orange Rubber)

- In order to see if the material under test was affecting the torque data, another material was tested in its place.
- This material was a 1.62mm thick orange rubber.
- The results show that the torque still goes negative and increases with rotation angle.
- This would indicated that slipping is also occurring with this material.

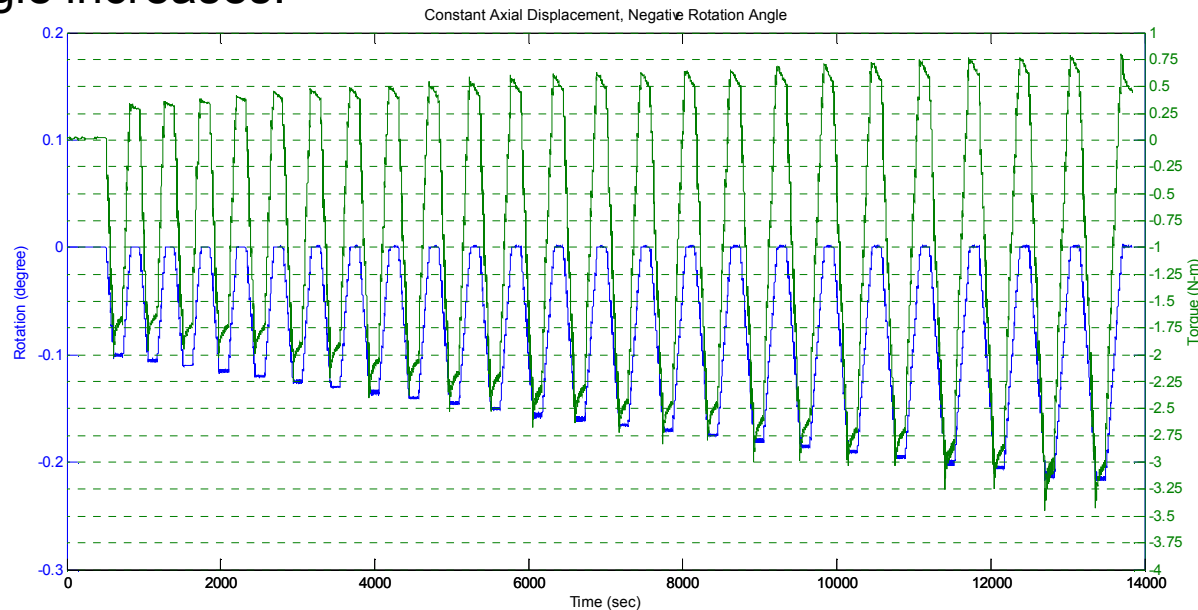
Slipping Investigation – Constant Axial Displacement, New Material Negative Rotation Only

- In order to ensure that the negative torque did not have something to do with the direction of rotation of the Instron (all tests had been completed rotating one direction), the same constant axial displacement profile was modified to rotate in the negative direction.
- This test was completed with the black rubber surrogate material because that happened to be in the machine at the time.
- The plot shows that the torque still crosses zero and gets higher as the rotation angle increases.

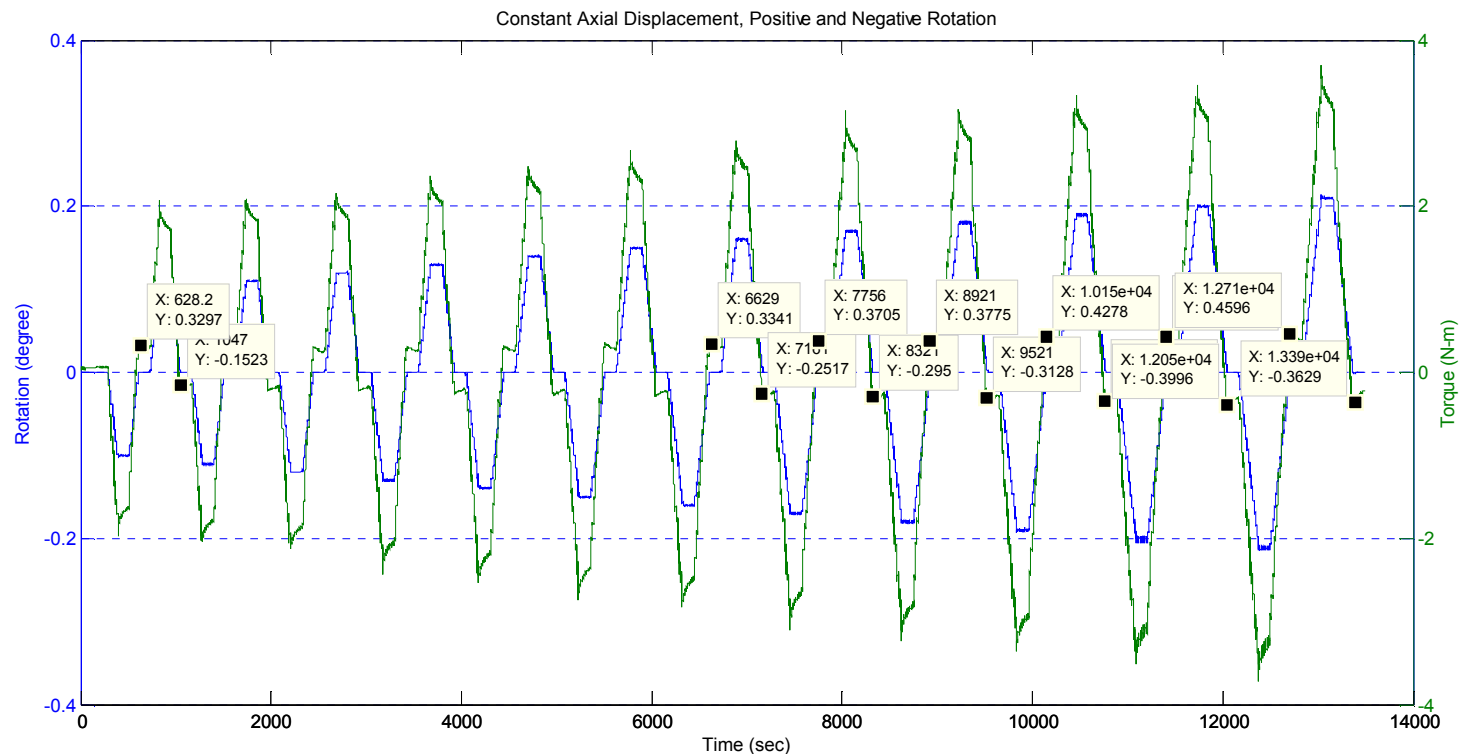
Slipping Investigation – Constant Axial Displacement, New Material Positive and Negative Rotation

- The surrogate material (black rubber) was also tested through alternating positive and negative rotations.
- The non-zero torque return was seen in all steps and still increased with rotation angle. It seemed to be slightly worse/offset from the negative rotation, but that could be from a slightly off zero calibration of the torque cell.

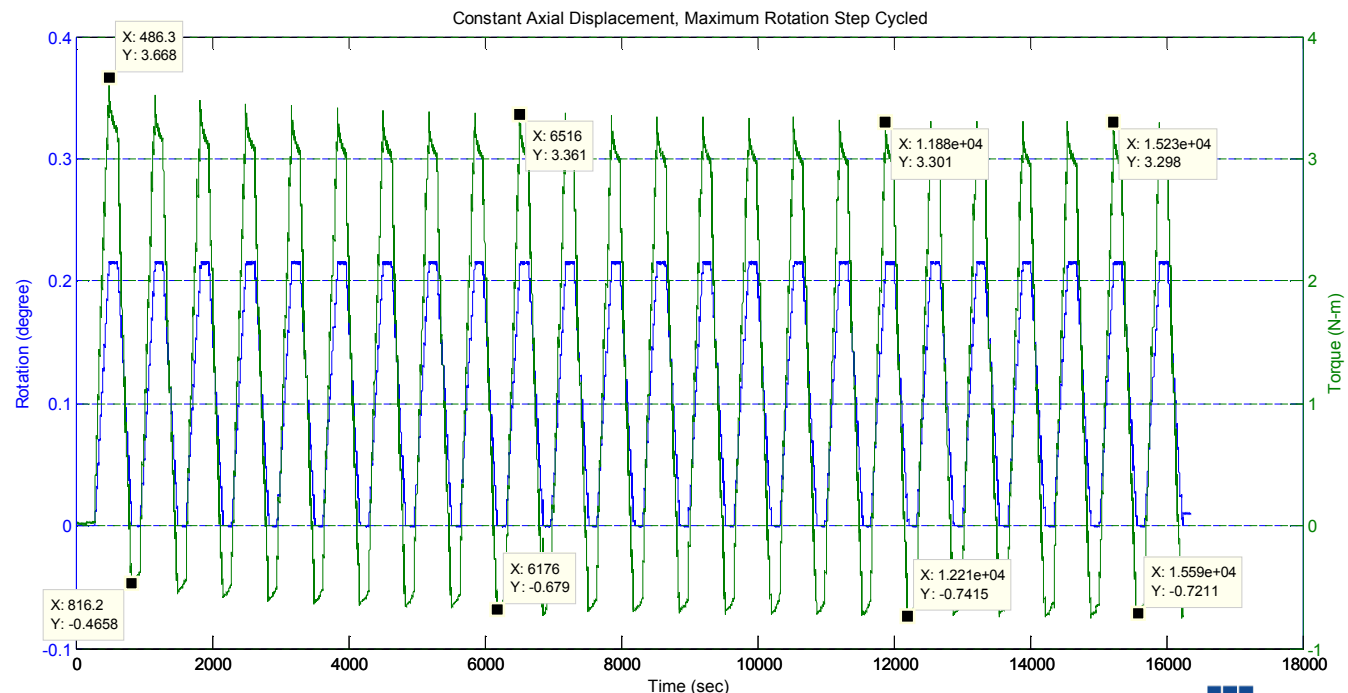
Slipping Investigation – Constant Axial Displacement, Maximum Rotation Step Only

- A test was conducted that just repeated that same rotation angle in one direction multiple times to see if the non-zero torque return got progressively worse or if it was stable.
- The non-zero torque return does get worse over the first 9-10 cycles and then stays about the same. This means it may be slipping a little more each time for the first 9-10 cycles.
- It is also interesting to note that the magnitude of the non-zero torque return here is about the same as that seen in the increasing rotation angle tests for the same rotation angle.

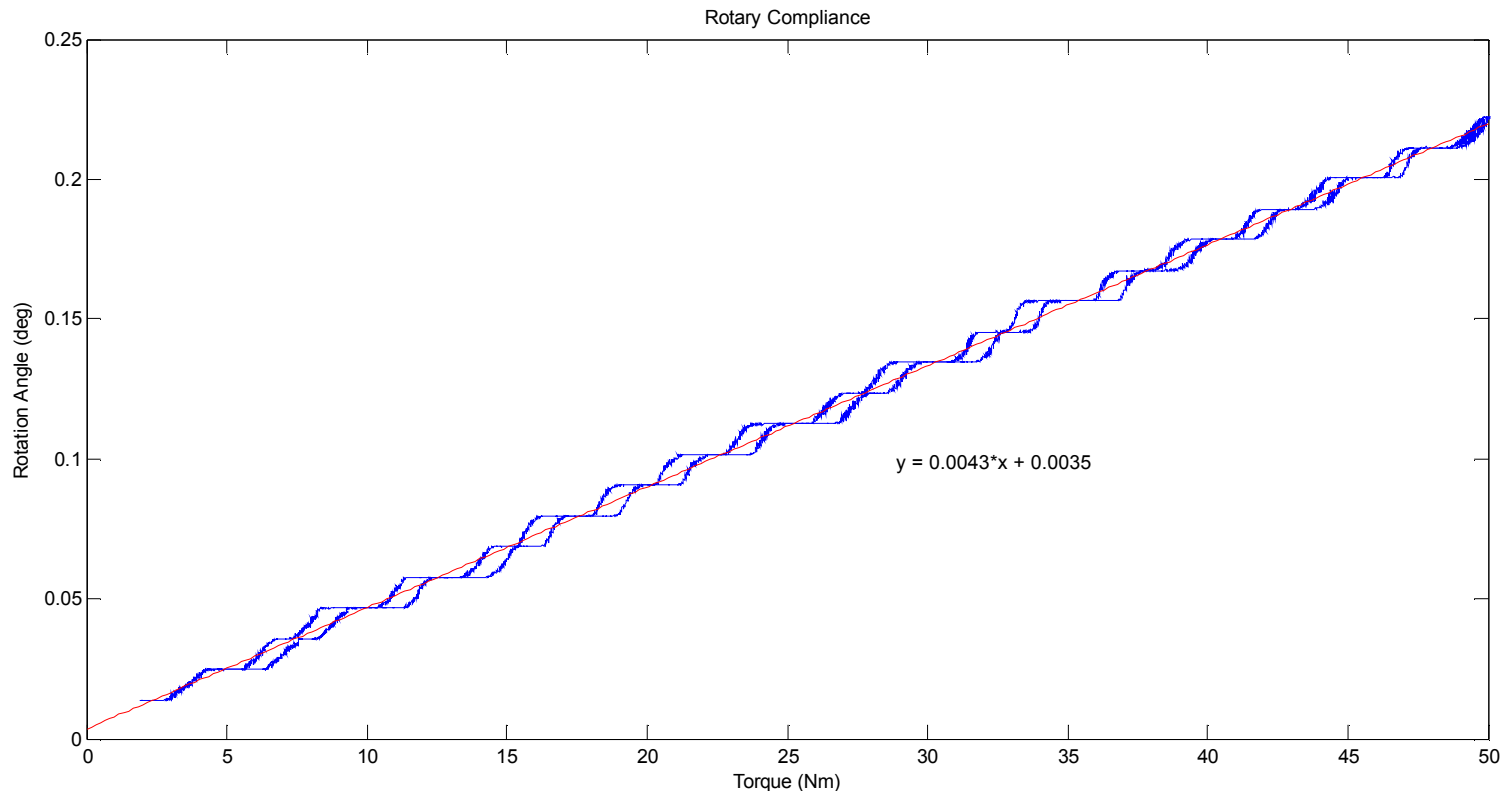
Instron Machine Rotary Compliance Testing

- The Instron rotational compliance linear curve fit is shown below.
- The maximum torque seen during the recent testing has been around 15Nm, which corresponds to a compliance of approximately 0.065 degrees, which is about 30% of the maximum angle of rotation controlled to during these tests.

- The rotational compliance of the machine is larger than originally expected and cannot be ignored.
- The torsional compliance is likely high due to the long push rods being used in the Instron.

- A better method for measuring rotational compliance should be developed.
 - At a minimum, sliding fit pins should be made to use in the place of the bolts to ensure that there is minimal slop to be taken up and it will help to more uniformly load all the pins and decrease the local compliance of the pins.

- Thought should be put into a fixture that can include the platens in the rotational compliance measurement.
- An alternative to performing a rotational compliance test is to measure the rotation at the sample (platens) instead of in the crosshead of the Instron. This would eliminate the need for compliance correction because the rotation measurement is made right at the sample location.
